# A<sup>o</sup> FLOOD PLAIN MANAGEMENT STUDY

For the Town of  
West Fairlee, Vermont

FLOOD PLAIN MANAGEMENT STUDY  
TOWN OF WEST FAIRLEE  
ORANGE COUNTY, VERMONT

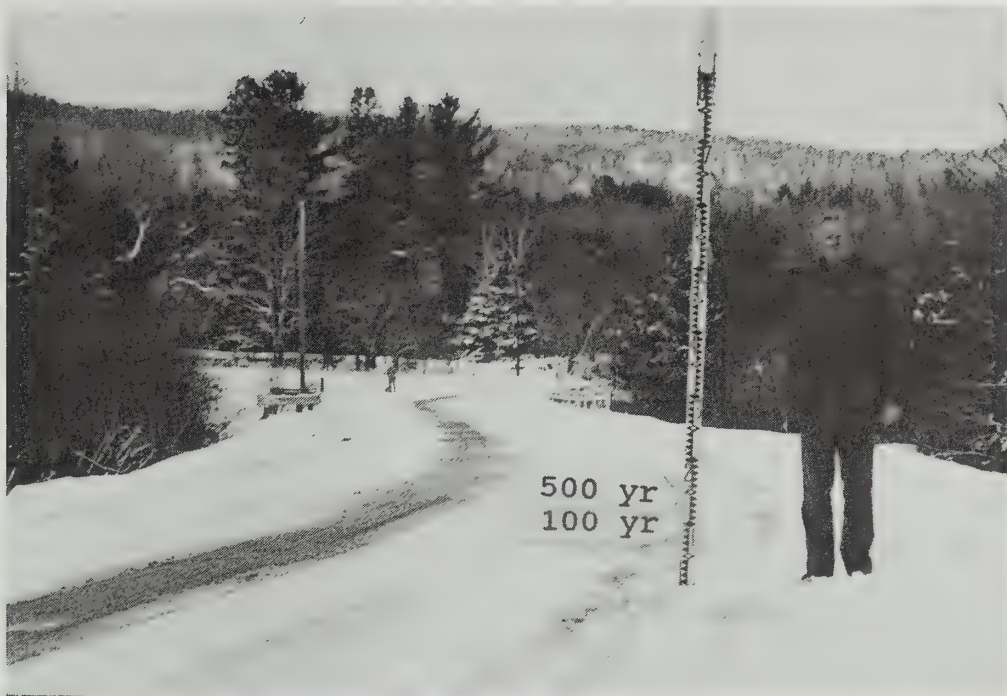
**Figure 3.** On Middle Brook road at first crossing of Middle Brook upstream of Beebe Pond

Figures 1 through 4 show the water surface level of the 100 and 500-year flood at selected localities.

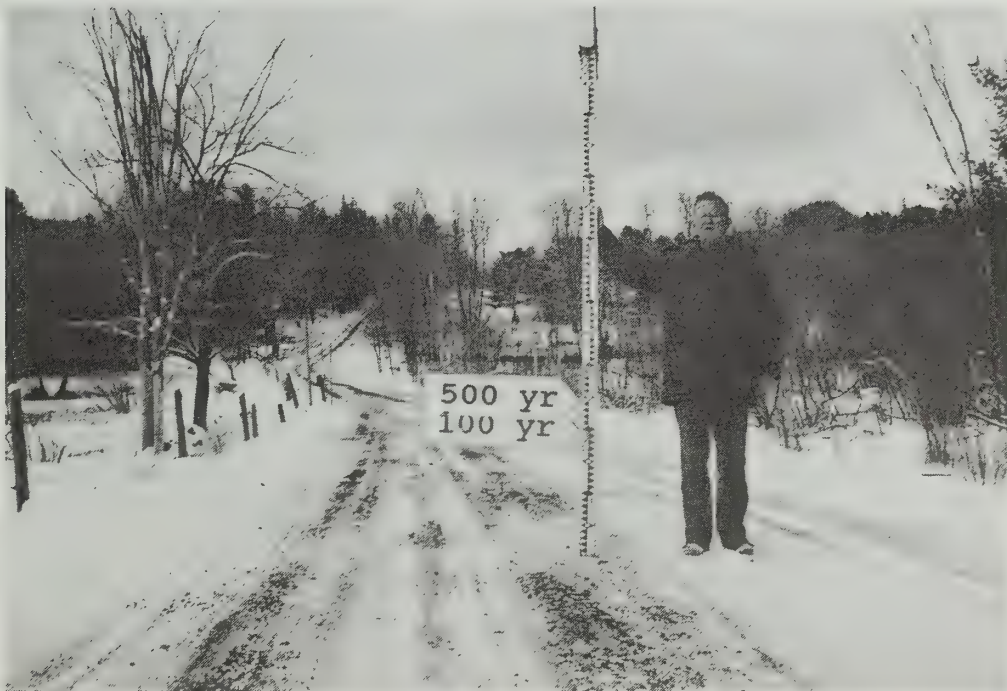
**Figure 4.** At first Blood Brook crossing upstream of Rt. 244, crossing in the background
